TEST REPORT

**INSTALLATION AND ENVIRONMENTAL TEST
OF LIGHT SIGNAL MONITOR FACILITY AN/TSQ-()**

DSL R-146

1 June 1966

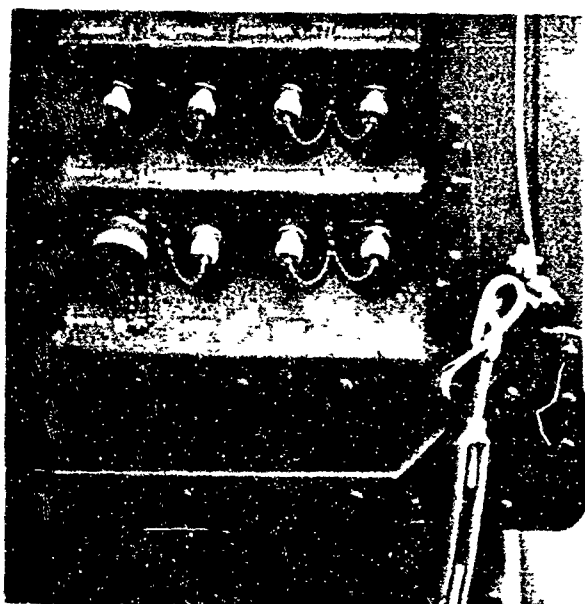
<u>Impact No.</u>	<u>Specified Impact Speed (mph)</u>	<u>Actual Impact Speed (mph)</u>	<u>Check</u>	<u>Results</u>
1	5	7	Operational	All equipment fully operable
2	9	9	Operational	Rear curb side shelter tie-down cable pulled loose (Figure 14). All equipment fully operable.
3	9	9	Visual	No visual damage.
4	9	11	Visual	Rear road side shelter tie-down cable snapped (Figure 15).

FIGURE 14. IMPACT NO. 2 DAMAGE

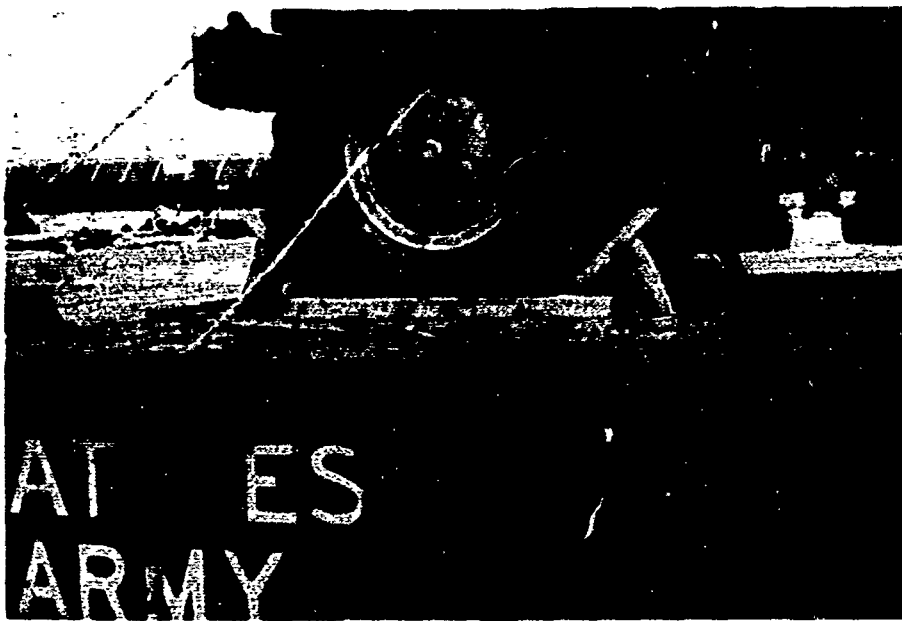
<u>Impact No.</u>	<u>Specified Impact Speed (mph)</u>	<u>Actual Impact Speed (mph)</u>	<u>Check</u>	<u>Results</u>
5	9	12	Operational	Front curb side vehicle tie-down cable snapped (Figure 16). All equipment fully operable.

FIGURE 16. IMPACT NO. 5 DAMAGE

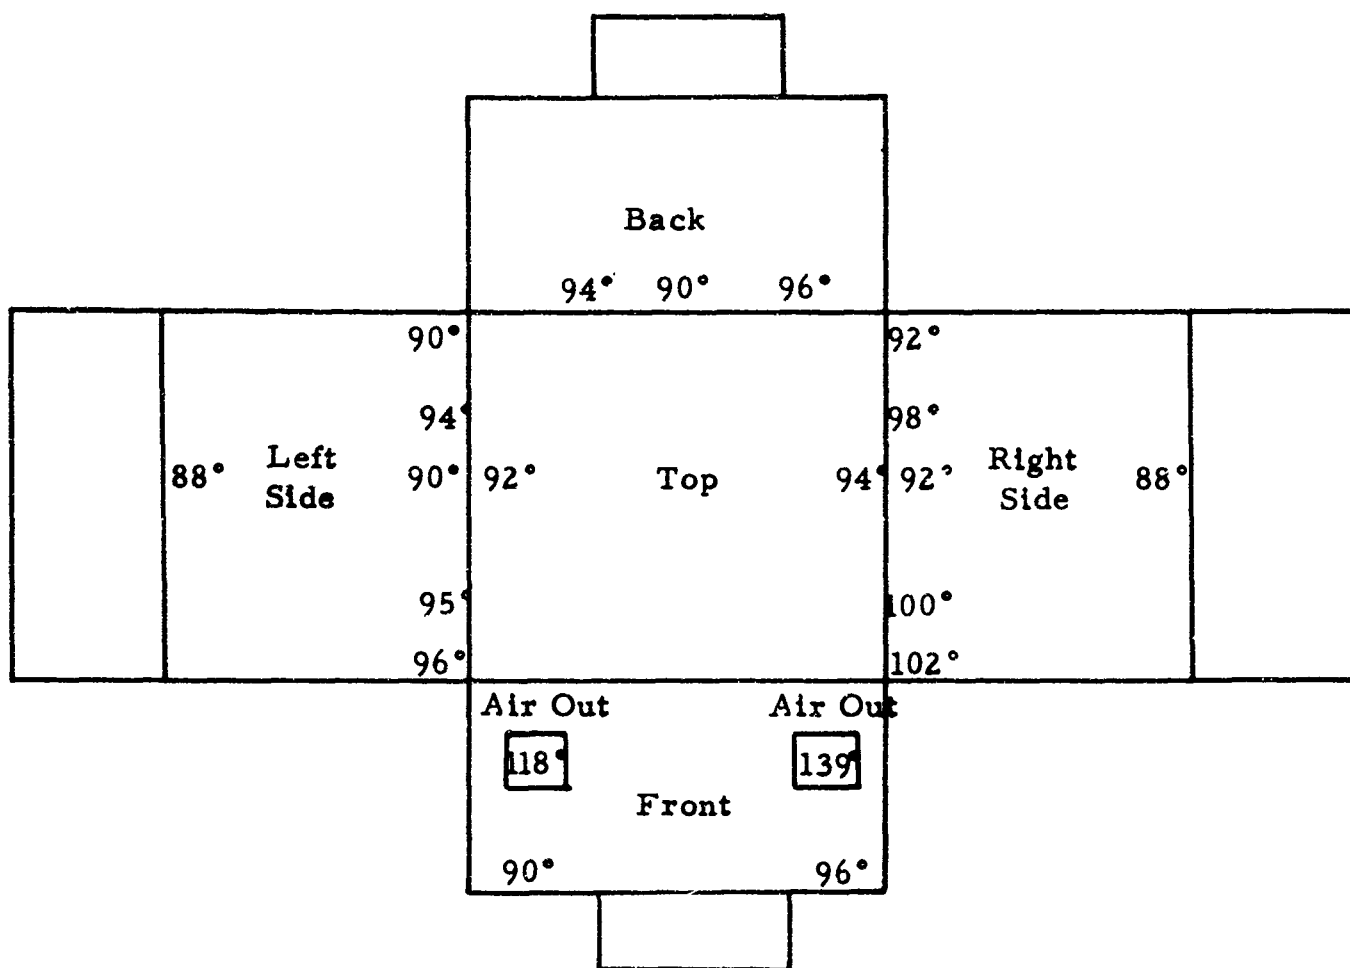
The AN/PRC-47 transceiver was keyed at its specified maximum duty cycle at high power throughout the duration of the heat test. To accomplish this, the drain plug was removed from the shelter floor and wires were run from an external key through the drain hole to the transceiver. The following table shows the front panel temperatures of the various system components at the completion of the heat test. Measurements were made by placing a Weston Model 2261 thermometer in contact with each front panel. Figure 28 indicates the temperature readings taken at various points on the shelter external surface at the completion of the heat test.

FIGURE 28. HEAT TEST - EXTERNAL SHELTER TEMPERATURES

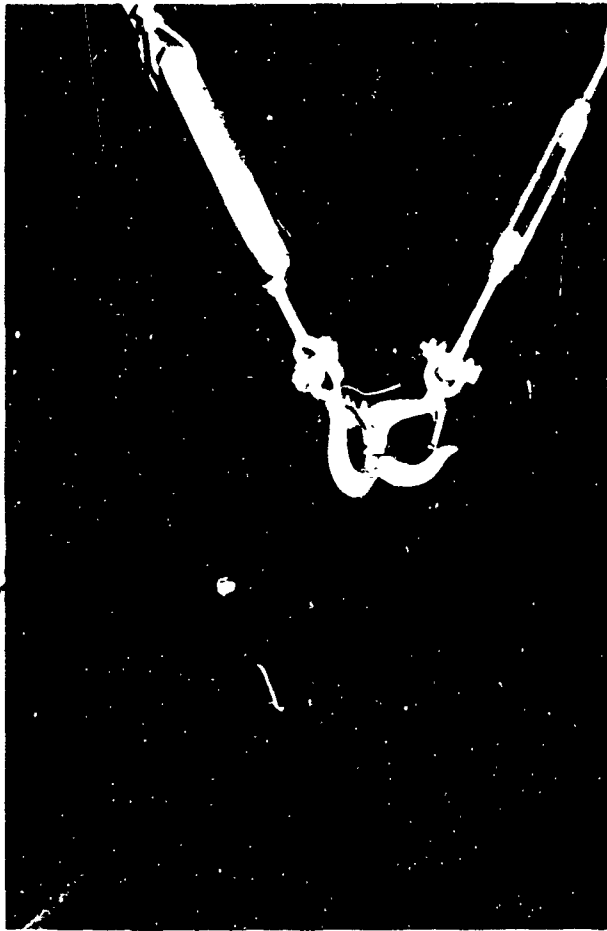
4. The diagonal tie-down cables used for the rail transport test are anchored to a bracket installed on the side of the truck bed. Prior to the test the shelter cleared the bracket by nearly 1/2 inch. After completion of the rail transport test, the shelter had settled onto the bracket sufficiently to deform

FIGURE 32. SHELTER DAMAGE DUE TO TIE-DOWN BRACKETS

the shelter as shown in Figure 32. It is recommended that, if this tie-down method is to be used, more initial clearance be allowed between the shelter and the bracket.
